SERVICE BULLETIN

EC08-018
 NTB08-088
 September 16, 2008

2004 - 2009 TITAN AND ARMADA; DTC P0335

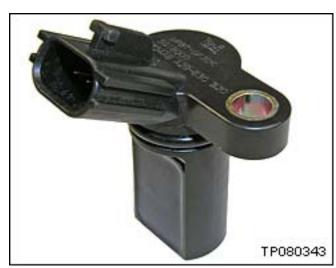
Figure 1

- The Crankshaft Position Sensor and Camshaft Position Sensor look identical (see Figure 1).
- When servicing / repairing the vehicle, or during a previous repair, it's possible to install these sensors in the <u>wrong</u> locations:
 - Locations swapped, or
 - > Two of the same sensor installed

Make sure the **Crankshaft** Position Sensor and the **Camshaft** Position Sensor are installed in the correct locations.
